Flamborough Head

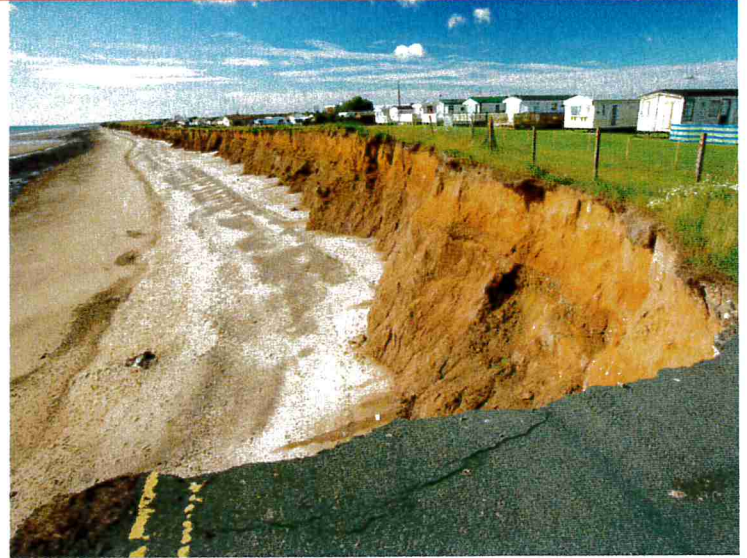
Figure 3 Recent erosion threatening the settlement of Skipsea, where rates of erosion are 2 metres a year

In response to the rapid rate of erosion and the threat to settlement and infrastructure, parts of the coastline have been protected with hard-engineering structures such as sea walls, rock armour and groynes (see 3.9). Although these interventions have helped to protect specific localities, such as Hornsea and Mableton, they have deprived areas further south of sediment, thereby exacerbating coastal erosion. The lack of a beach renders cliffs much more vulnerable to undercutting and collapse (Figure 3).

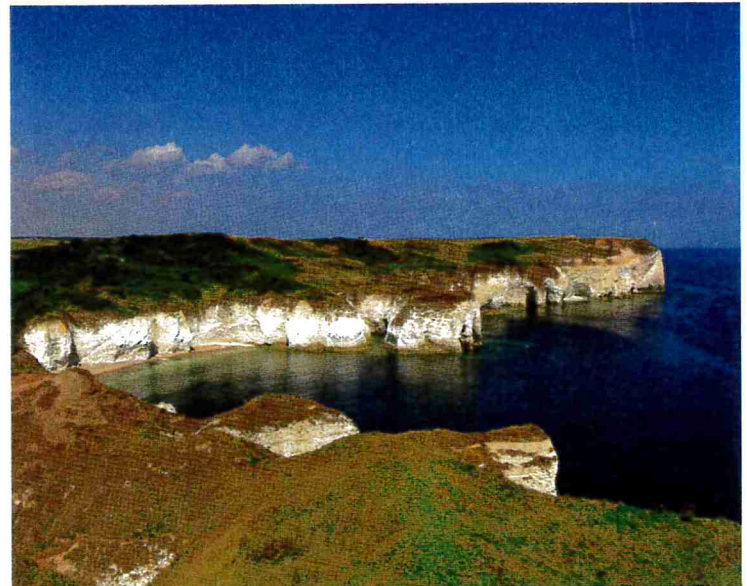
Figure 4 Distinctive chalk cliffs at Selwicks Bay, Flamborough Head

Chalk has a very distinctive white colour, as can be seen in Figure 4. The layers or beds of the chalk are clearly visible and are roughly horizontal (Figure 5). Vertical cracks run through the chalk (*joints*). In some places whole sections of chalk have been displaced along lines called *faults*. These joints and faults are weaknesses in the chalk, which are readily exploited by the processes of weathering and erosion to form narrow clefts in the coastline. One major faultline has been exploited to form Selwick's Bay (Figure 4).

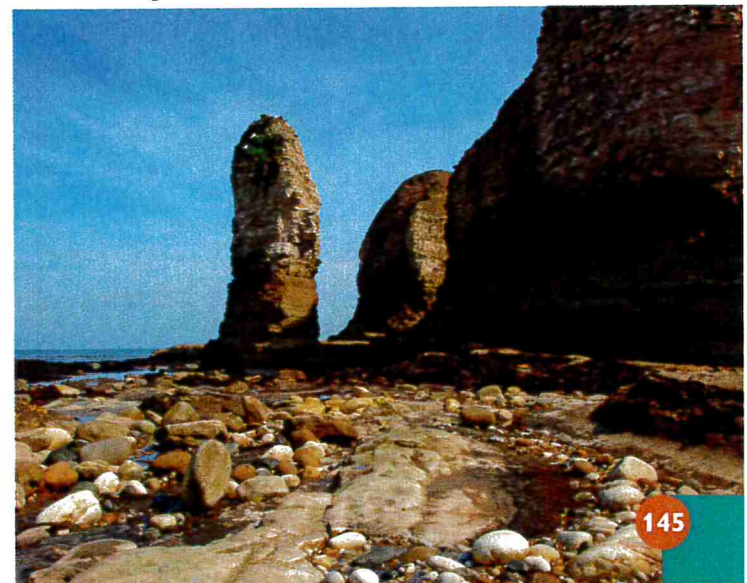
Figure 5 Landforms of coastal erosion at Flamborough Head

The sea is actively eroding and undercutting the base of the cliffs leading to frequent rockfalls. The high tide line is clearly shown by the dark staining at the foot of the cliffs in Figure 5. Over time the cliff retreats, forming wave-cut platforms and stacks.

- 2 What are the factors affecting the cliff profiles and rates of cliff retreat along the Holderness coast?
- 3 Study Figure 5.
 - a Was the photo taken at high tide or low tide? Justify your answer.
